vision systems

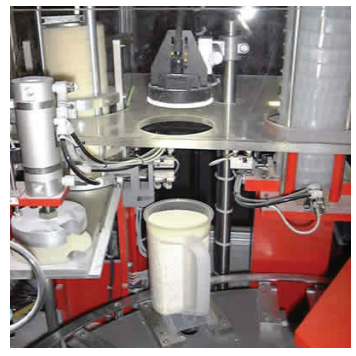
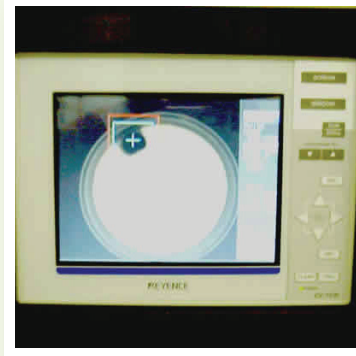
The images on the right side of this page show the camera used to detect the correct fitting of the top filter around the profile of the pot

To eliminate any possibility of this situation occurring a dual camera Keyence CV-700 vision system was installed.

This system was used to check every pot, in process, to detect the correct fitting of the filter at the bottom and top of the pot.
